Inspection Report Exclusively For: Heesook Park Report Number 3916

RFB PROPERTY INSPECTIONS
 18198 Bryce Ct.
 Fountain Valley, CA 92708
 714-317-3792

FINDINGS

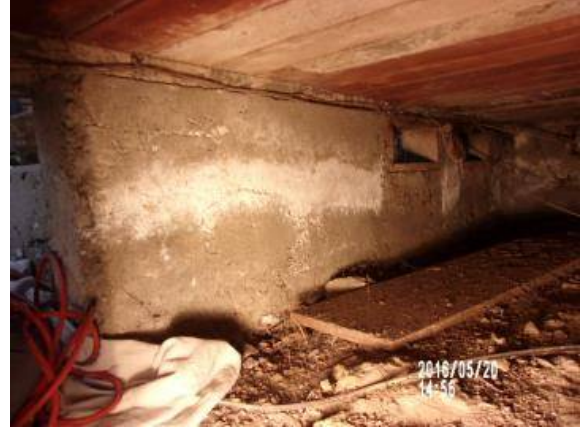
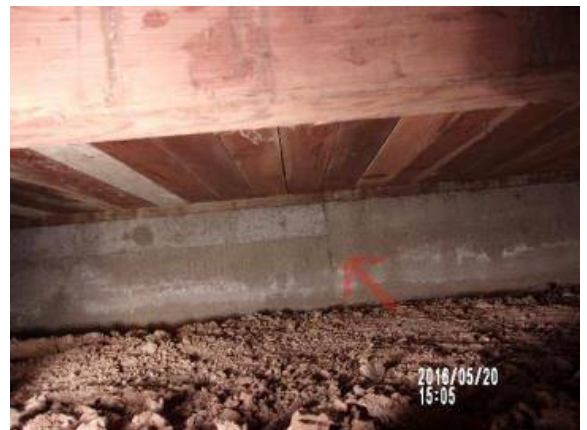
[FE] The foundation had cracks and some deterioration. Water should be diverted away from the foundation as much as possible. A complete system of gutters and downspouts are highly recommended with drains draining to the street if possible. Drains every 8 feet are also recommended around the home draining to the street as well. Some drains were noted. We recommend testing the drains periodically. A couple of the drains had debris, cleaning recommended. There was a condition known as efflorescence on portions of the foundation walls. This is a salt deposit left when moisture in the foundation evaporates. It indicates that the foundation is experiencing wet and dry cycles in heavy rains. We recommend the exterior grading and drainage be improved to divert moisture away from the foundation. Flower beds in the front of the home did not have any visible drains as well. When foundations are over 50 years old we always recommend a further evaluation by a Geo-Tech Engineer for structural and drainage issues. Cracks noted.

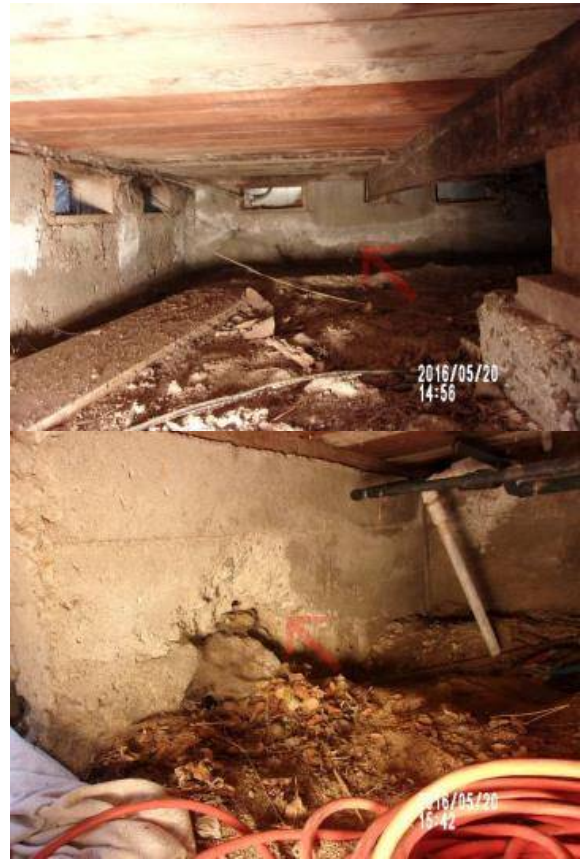
Deterioration noted.

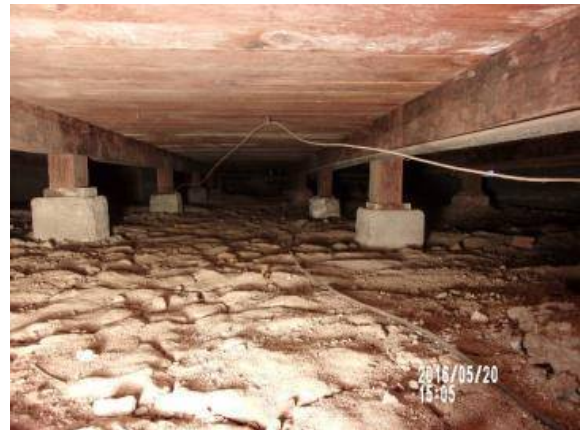
106 PIER(S)

[FE] Some of the piers and posts had deterioration, see the termite report.
[RU] Piers, posts, beams and general framing were toe nailed together. This is older technology. We recommend upgrading to incorporate approved metal brackets and connectors in the foundation system to perform better during seismic activity.

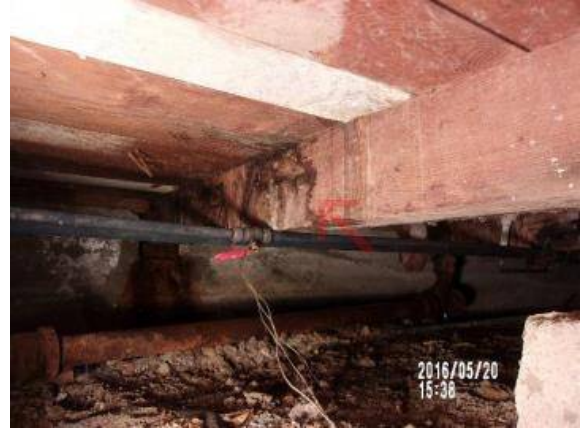
107 FRAMING

[FE] Some moisture stains and deterioration were noted at various locations, see the termite report for a further evaluation. When moisture stains are noted, mold inspections are recommended.

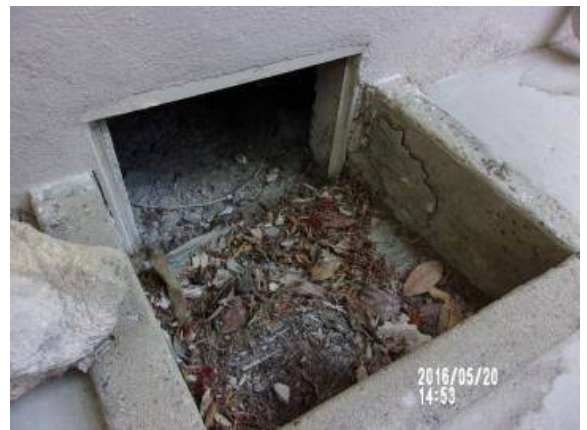
[FE] The access screen door panels had some damage and did not fit properly. Access openings should be 22 inches by 18 inches high, these were less. Access should be 18 inches high, this was less. Piping in crawl spaces should be at least 12 inches off of dirt, these were less. Access was difficult, corrections recommended.

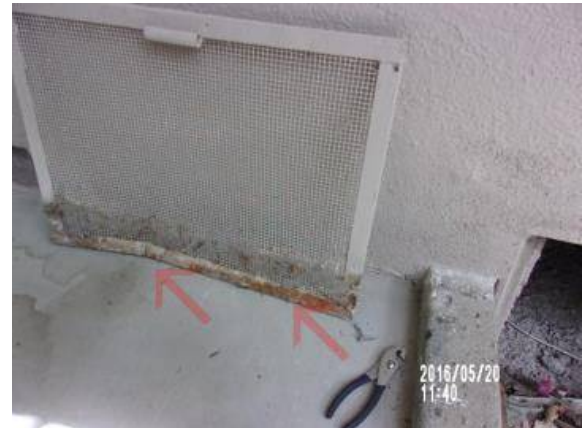
Access panel damage and rust.

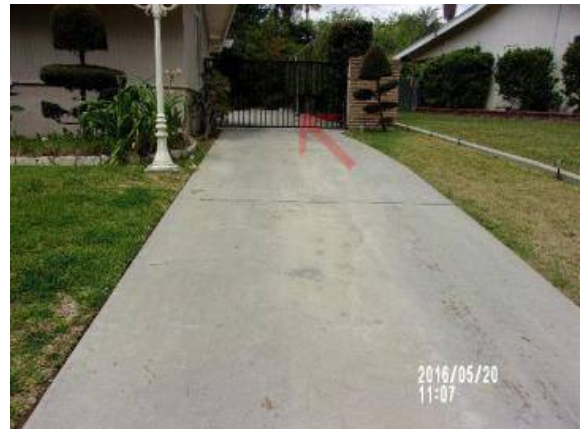
The driveway had cracks and stains noted. Filling cracks is recommended to prevent lifting concrete creating trip hazards. Vehicle gate had some rust. The gate roller was making marks in the driveway. Ask for the car remotes. Button found in the garage on the wall. Ask the age of the unit, average life is 10 years.

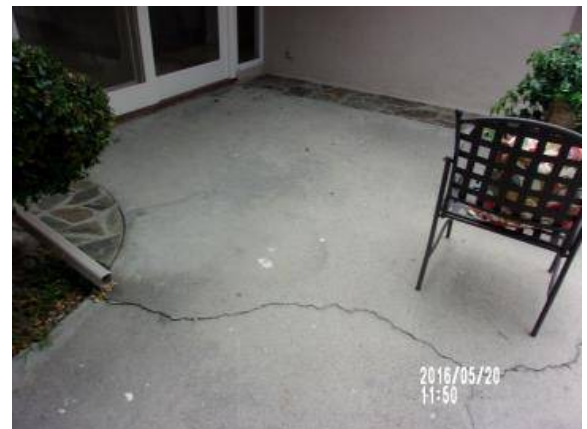
[FE] There were cracks and stains in the patio. We recommend sealing all cracks to help prevent lifting concrete causing trip hazards. [SC] Uneven sections were noted in the patio surface. This condition is a trip hazard. Leveling this condition is the typical remedy.

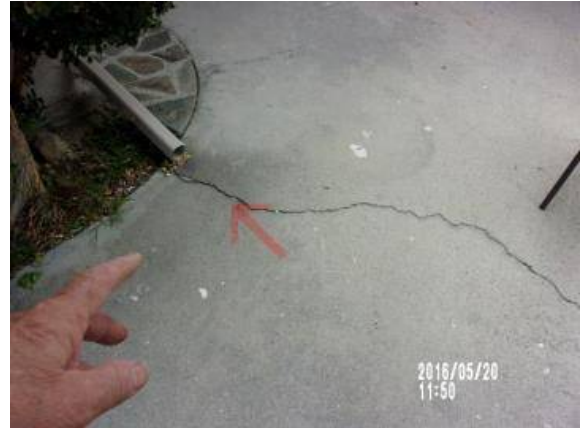
Trip hazard.

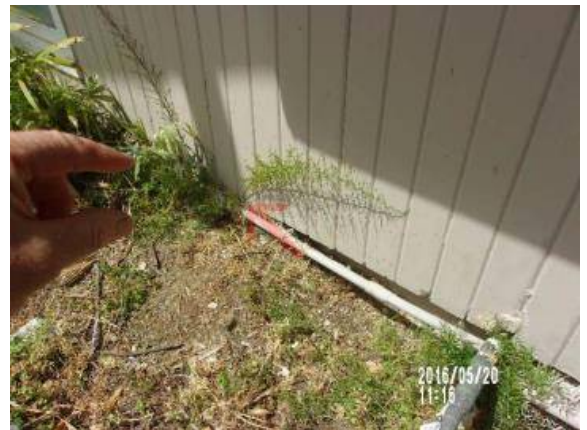
[FE] Portions of the wood siding lacked adequate clearance from the ground and hardscape. Six inches from dirt and 2 inches from hardscape. These conditions are conducive to moisture intrusion/deterioration. Some patching/deterioration noted. See the termite report.

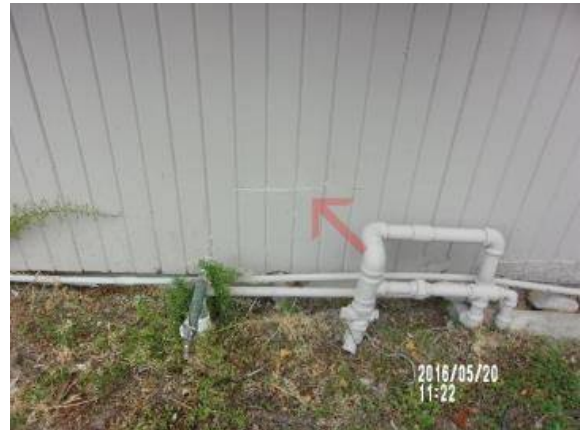
Patching noted.

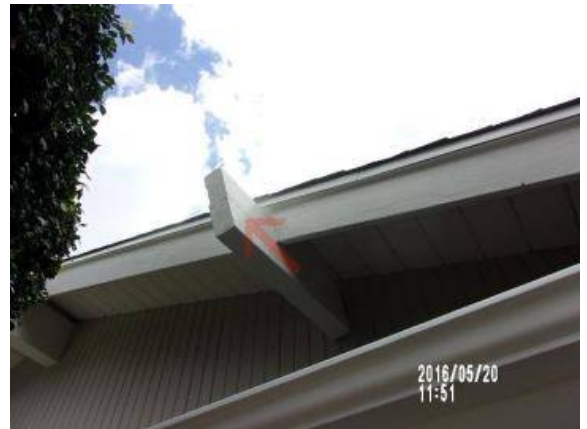
248 EXTERIOR TRIM

[FE] The visible exterior trim materials appeared mostly functional. Some deterioration was noted in various areas, see the termite report for a further evaluation.

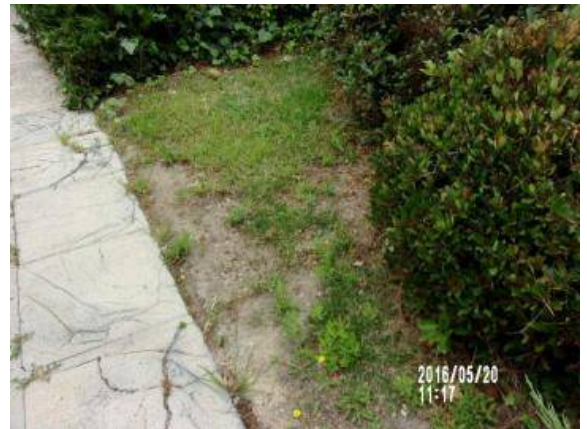
251 LANDSCAPING

[FE] The vegetation and landscaping needs attention. Grass had bare spots. Trees and bushes need trimming. Large trees were noted that could create major damage, a further evaluation by an expert recommended. Some of the trees had metal wrapping, ask the seller why? Trees/large bushes are not recommended too close to the home. We recommend considering removal, as trees/bushes continue to grow in size and damage may occur to the foundation, structure or roof.

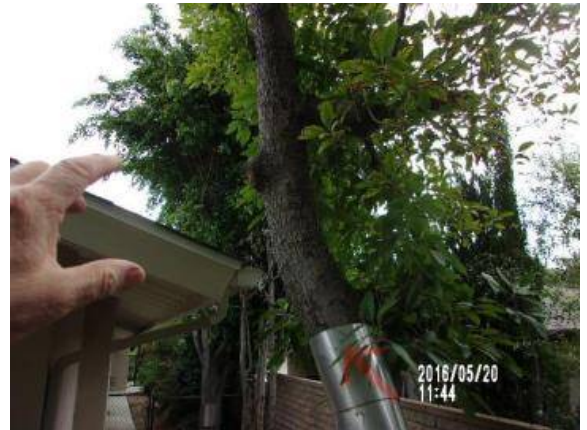
Damage may occur. Metal noted.

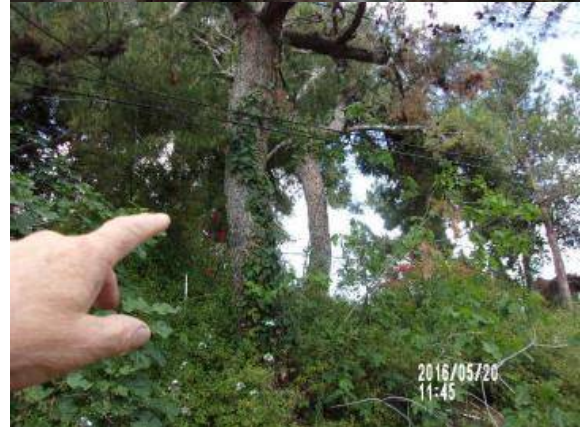
Large trees in the back could cause major damage as well.

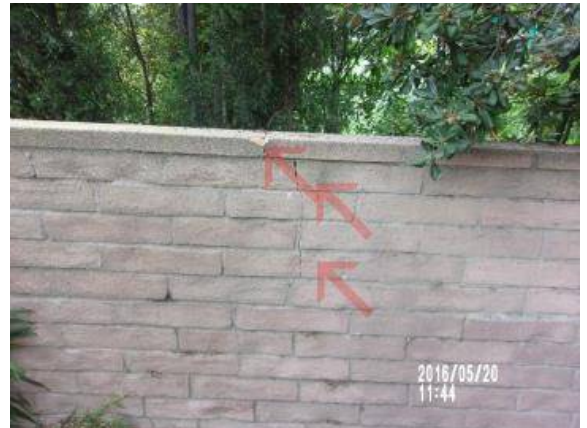
[FE] The masonry fencing had minor cracks and chipping noted. Wrought iron and chain link fencing had some deterioration. Pool equipment wood fence had damage. [SC] The left gate did not meet the present pool safety standards. The gate should be self closing and self latching. It should also swing away from the pool area. Alarms at doors and windows leading to the pool area are also required. The vehicle gate should be closed at all times.

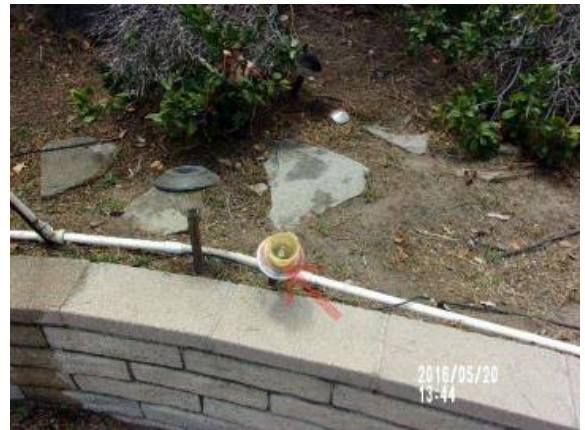
[FE] The malibu lights did not operate. Some appeared damaged.

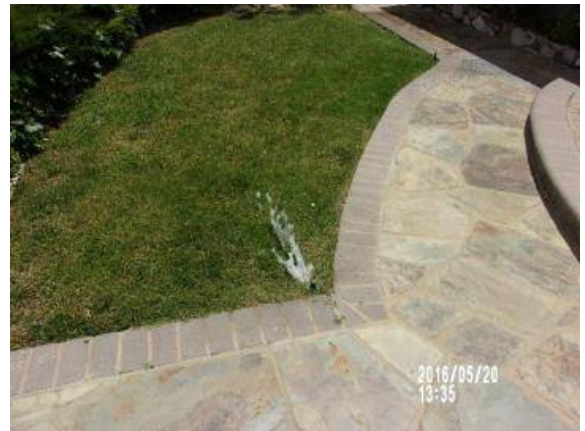
**265 SPRINKLERS**

[FE] Sprinklers are very difficult to inspect. Sprinkler heads are always in need of adjustments, are missing, or are broken/damaged. Underground piping cannot be inspected except for observing possible leaks at the surface. Sprinklers should not spray on the home, fencing, or hardscape. At the time of the inspection sprinklers were turned on at the valves only, timers are not tampered with since settings may be lost. The sprinklers at this time need adjustments, some appeared to be missing, full coverage is not assured. Ask the seller to demonstrate the sprinklers and timers and corrections can be made.

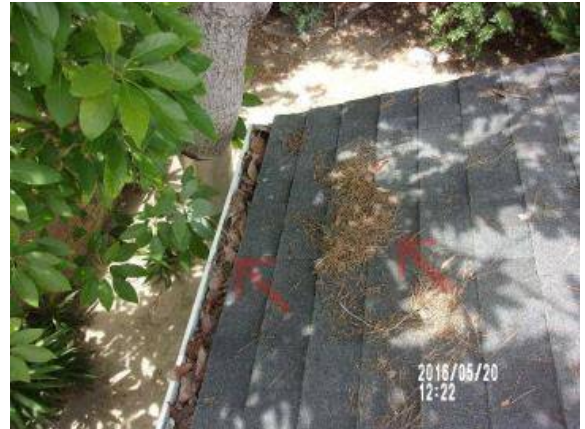
[RU] The home did not have a complete system of gutters and downspouts to direct the roof rain water away from the foundation. We recommend adding gutters and downspouts for proper drainage. [CR] The gutters had some debris which restricts proper drainage. We recommend cleaning.

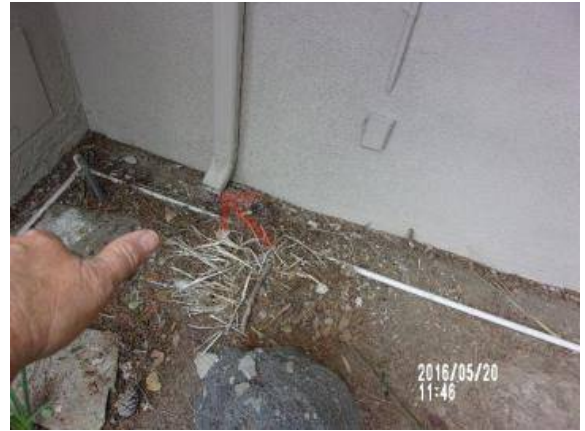
318 DOWNSPOUT(S)

[CR] Runoff water from the roof discharged next to the home. We recommend the downspouts be routed sufficiently away from the home to prevent ponding, pooling, and saturation of the soil at the foundation.

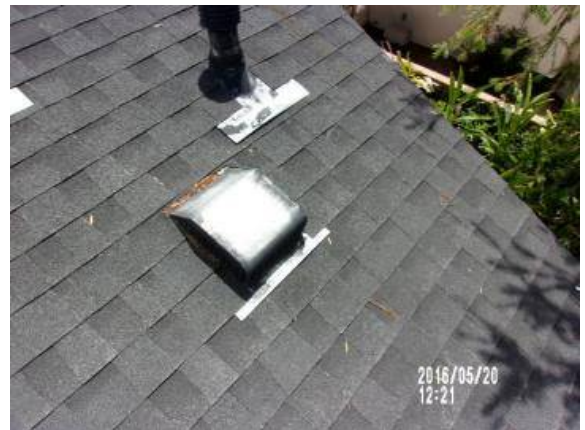
[FE] The flashings had minor cracks. Re-sealing the flashings is typically recommended by a licensed roofing contractor. There are lifted, unsecured and unsealed flashings noted. Paint issues noted. All flashings should be painted to prevent rust/corrosion.

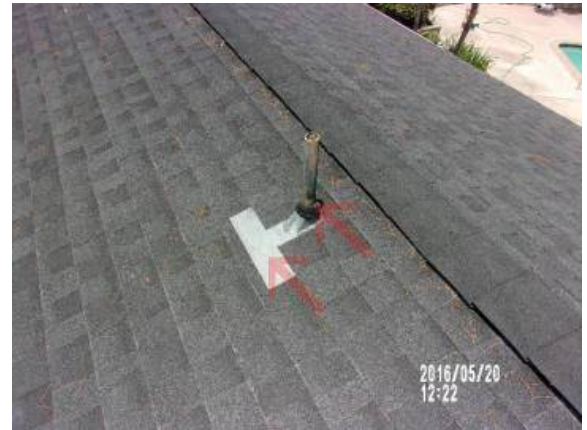
Minor cracks and painting issues at various areas. .

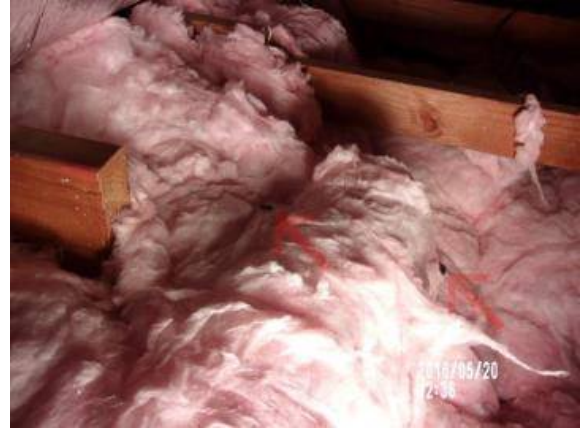
[FE] Possible rodent activity was noted in the attic. We recommend a full evaluation and/or correction by a licensed exterminator.

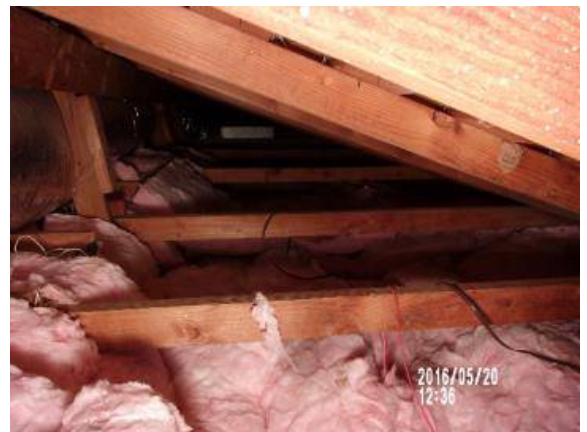
[RU] The attic space had minimal insulation installed by today's standards. Today's standard is 12 inches thick, this was 6. We recommend installing additional insulation for energy efficiency as an upgrade. [CR] Some of the insulation was out of place/missing in areas. This condition minimizes the overall value of the insulation.

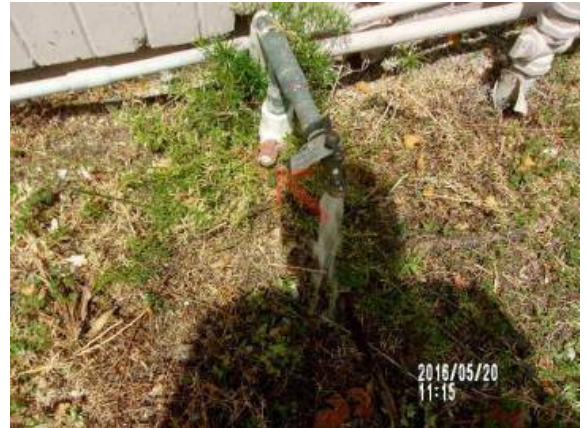
[FE] The main water shut off was located in the front. Maintenance is recommended periodically by turning and lubricating. The valve handle was damaged. The water pressure was high at 75 PSI. [RU] There was no regulator installed.

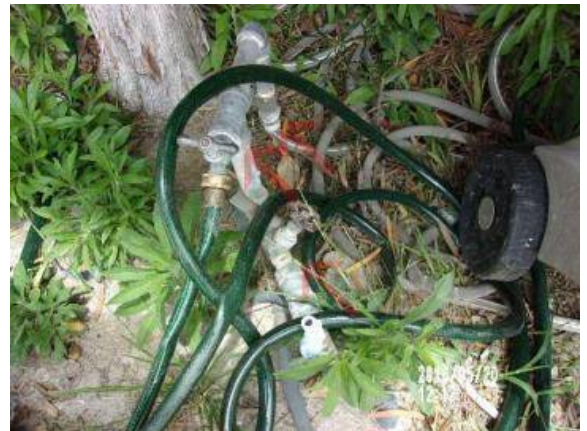
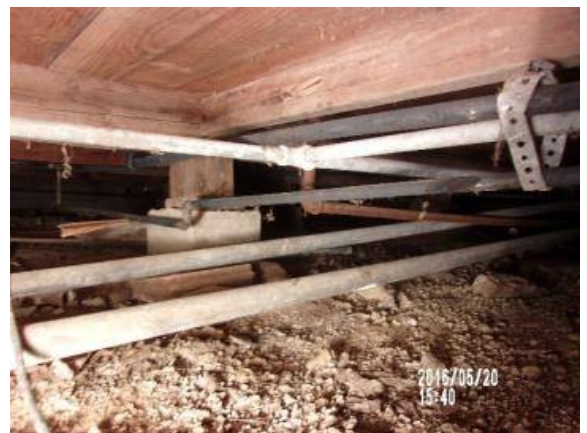
[FE] The galvanized piping at the exterior hose faucets and various areas had some corrosion as well as the valves. Galvanized piping rust/corrodes from the inside out. When corrosion is noted the piping is nearing the end of its useful life. Galvanized piping in the crawl space was disconnected and should have been removed. Copper piping was noted in the crawl space and in the bathrooms. There were un-insulated copper water supply pipes. All exposed water supply pipes, hot or cold should be insulated. The cold water lines will get hot in the summer and the hot water lines will get cold in the winter wasting energy. Copper piping in the crawl space was not properly strapped. Galvanized piping in the crawl space blocks access and should have been removed.

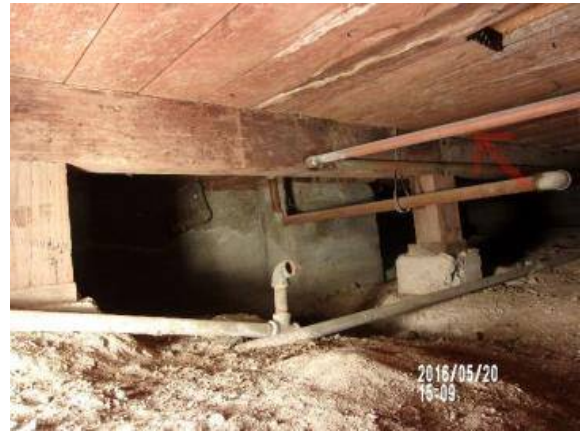
Uninsulated copper piping and straps were missing in various areas.

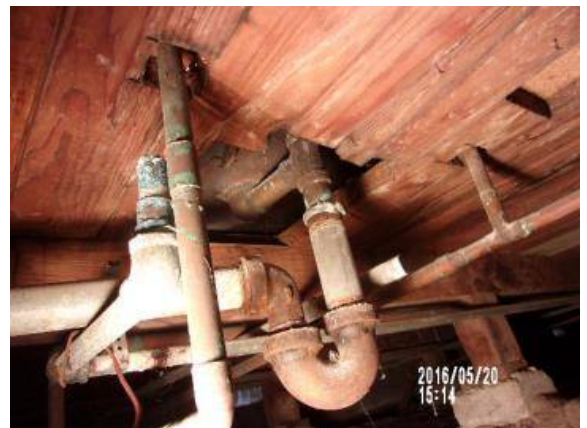
[FE] The drains in the crawl space had major corrosion and leaking. We recommend three plumbing contractors for evaluation and repair pricing comparisons. This could be expensive. The middle bedroom bathroom sink drain was a little slow draining as well.

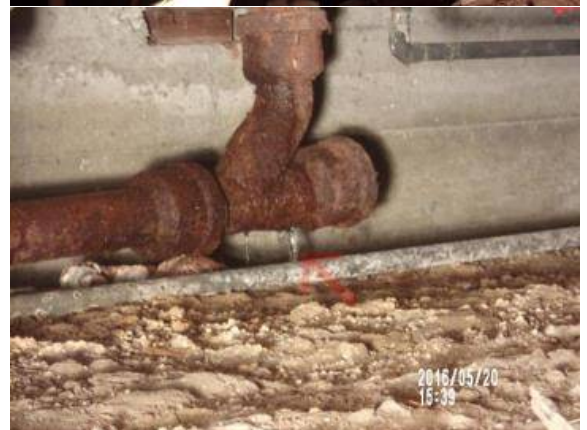
Leaking noted.

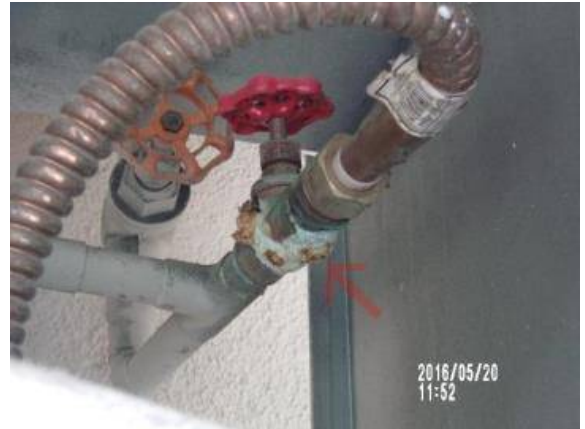
[CR] The visible water supply connectors appeared functional, they were not fully insulated on all three. It is today's requirement to insulate the exposed water piping both hot and cold. The shutoff valves had some corrosion. If turned they may begin to leak. A further evaluation recommended by a licensed plumbing contractor. [RU] Bonding is recommended. We recommend a licensed plumbing contractor bond the hot, cold, and gas lines together at the water heaters for safety.

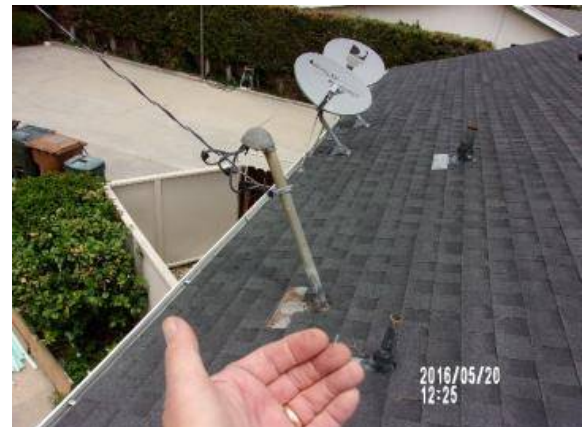
[SC] The overhead electrical mast was bent over and may disconnect. Correction recommended immediately by a licensed electrician. Tree branches were in contact with the overhead service entrance cables. Wires could become disconnected in a wind storm. Wire insulation becomes worn as well.

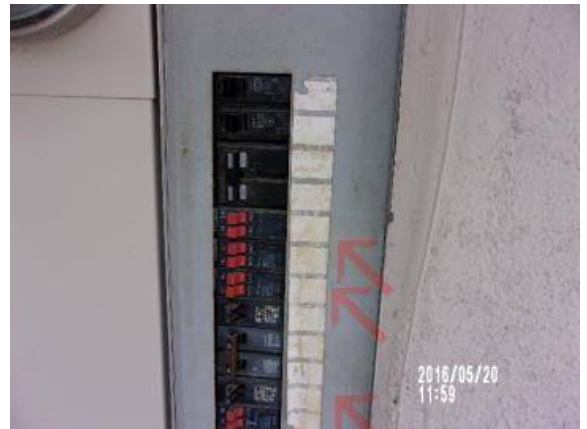
[SC] Some of the breakers were not labeled properly, they were fading. We recommend they be accurately labeled to allow individual circuits to be shut off for maintenance or emergency needs. The panel cover hinges were loose, repair recommended.

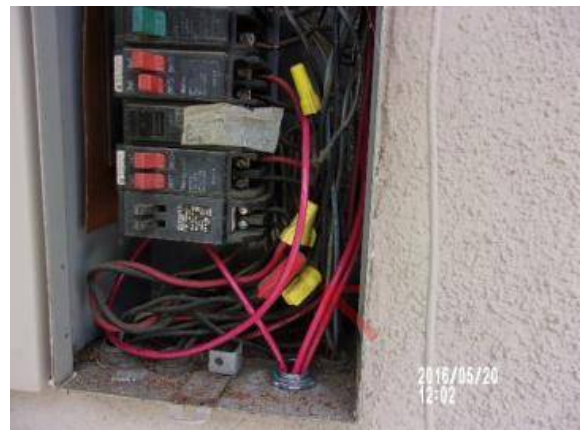
614 WORKMANSHIP

[FE] There were disconnected wires noted, ask an electrician why?

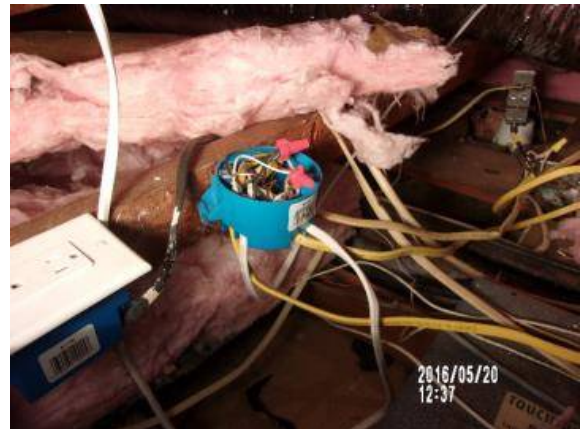
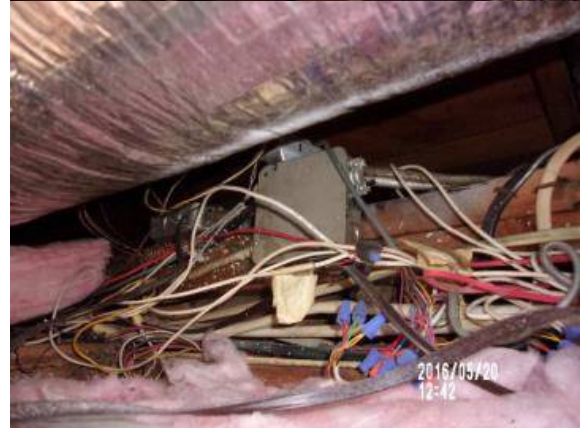
Loose wiring.

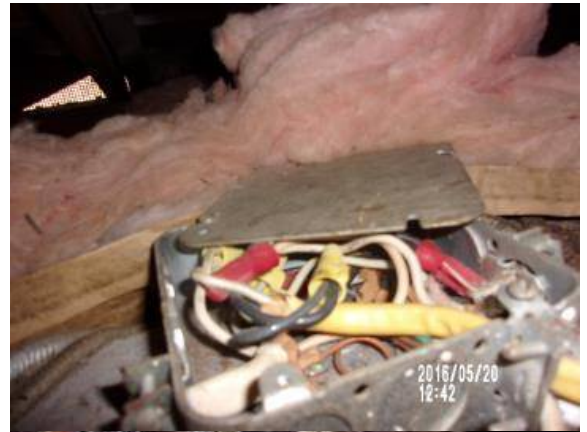
Improper.

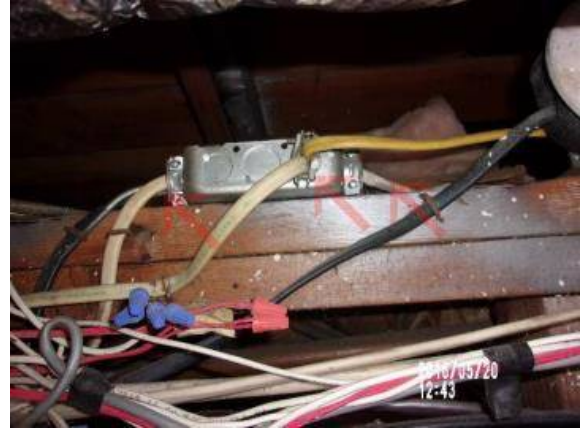
Over loaded.

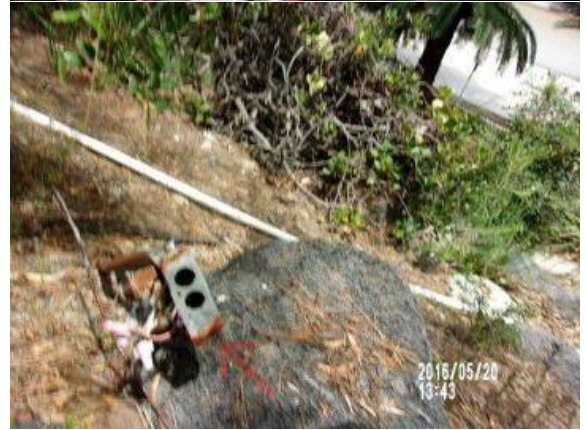
Damaged wiring/box at the back exterior.

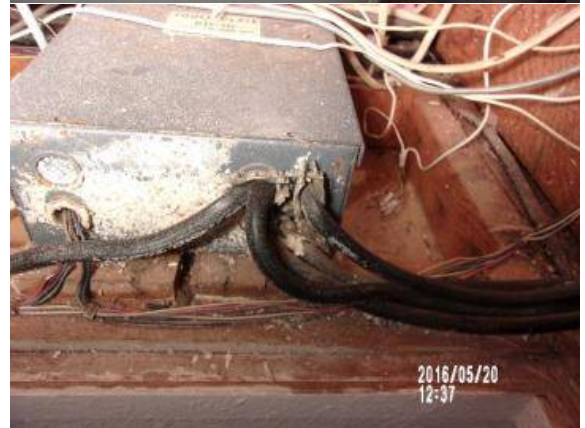
Old switch box relay system needs evaluation by a licensed electrician.

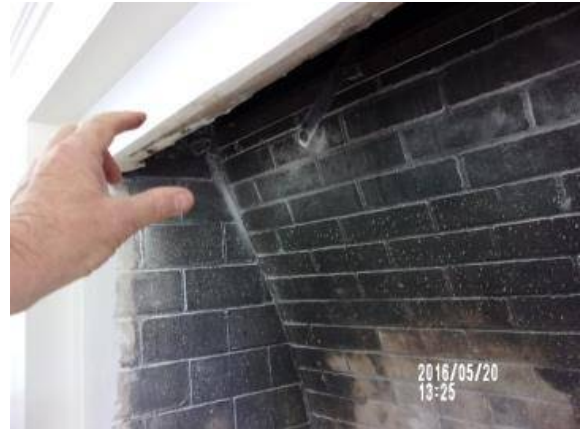
[FE] The firebox design may let smoke into the room. The gas pipe was also too close to the opening. Openings noted above, repair recommended. Have a Certified Chimney Sweep make a further evaluation. Gas pipe ring at the floor was loose.

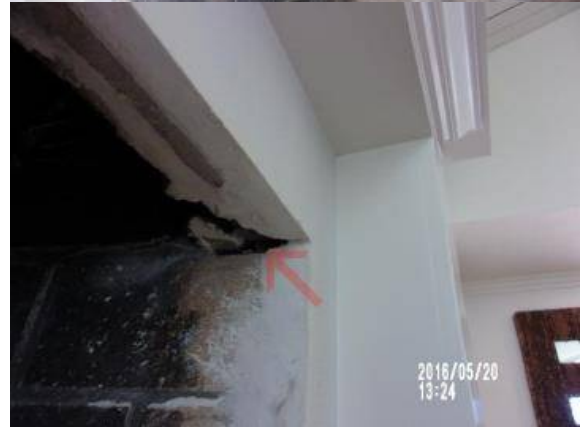
Openings noted above.

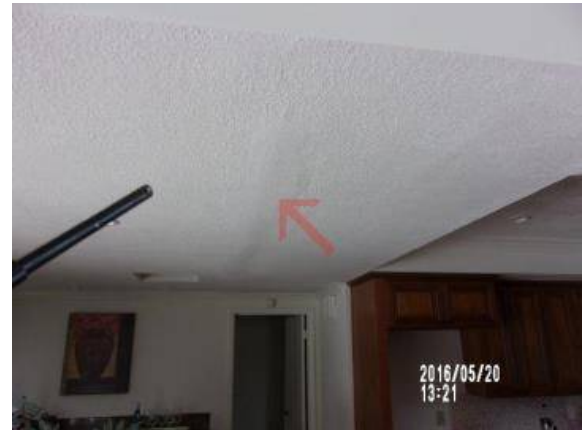
Unprofessional patching.

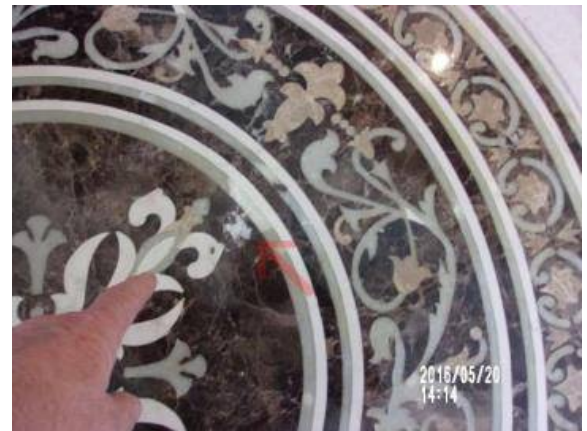
[FE] Grout issues were noted around the bathroom fixtures, cabinets, sliding glass doors, walls, and around door jambs. Loose tile was noted in the kitchen by the sink. Loose tiles were noted in the bathrooms in various areas. Some chipping was noted in the kitchen in various areas. Damaged tile was noted at the entry design tiles.

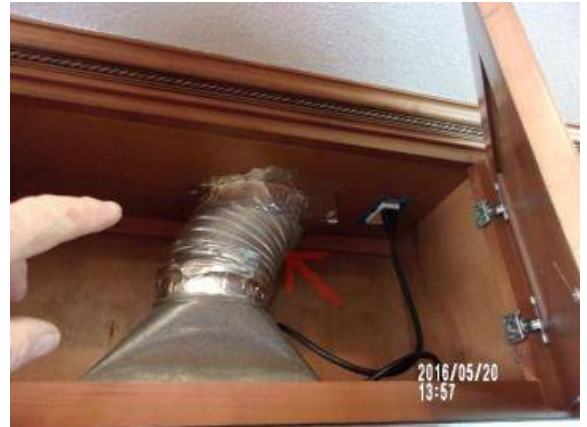
[SC] The visible portion of the exhaust vent ducting was a corrugated flexible material, this type of ducting was not approved for kitchen exhaust vents. Corrugations allow grease to be trapped, and is a possible health, and fire hazard. Solid piping is required. The auto fan button was not operational. Receptacle cover was missing.

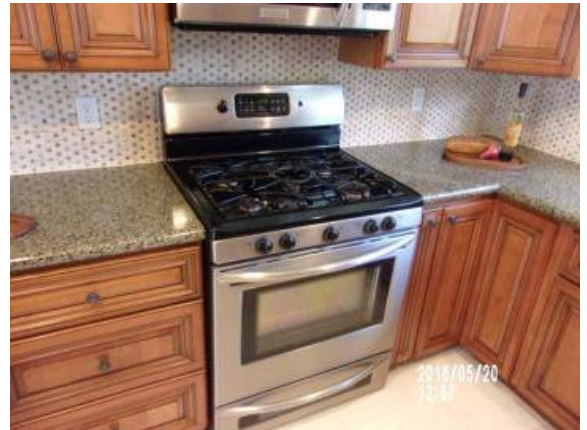
932 STOVE/OVEN

[FE] The gas free standing oven/range front right burner did not light the first time. The Average life is 10 years for most appliances. Ask the seller the age, if there are any warranties, and if there are any instruction books for all appliances. The oven was functional. [SC] An anti-tip device is highly recommended at the free standing range when you have small children. Children have been known to stand on the oven door, and have been able to tip pans with scalding water over with injuries occurring. This device will stop the range from moving, although the children maybe able to reach the pans above. Caution should be taken. The manufacturer always supplies this device, ask the seller if they have stored it?

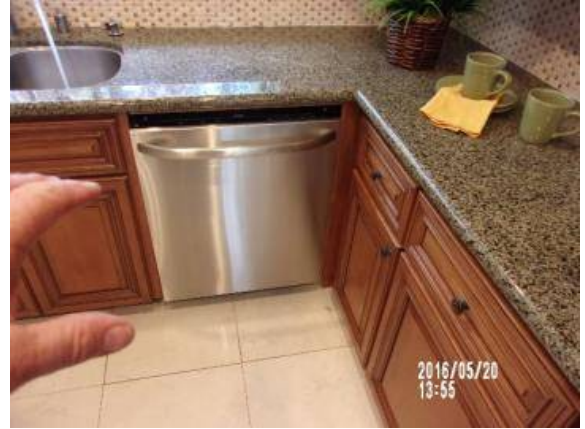
[CR] Leakage was noted at the air gap device. The dishwasher was shut down because damage may occur. This condition will only get worse. This is usually caused by food particles blocking the drain line.

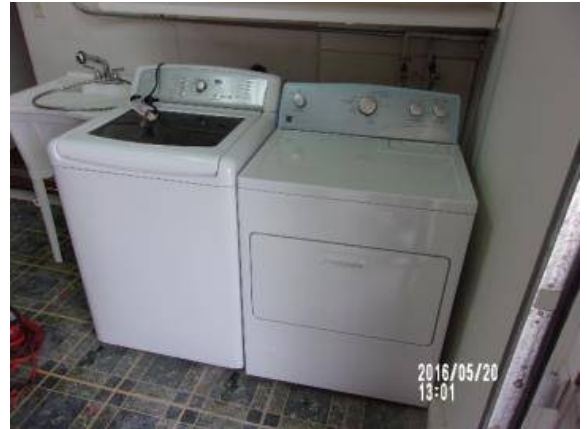
[FE] The washer/dryer was not tested, they are the seller's/tenant's. Ask the seller the ages and if there are any warranties if you are going to receive or purchase the units. The drain connections appeared improper, check for the permit? Valves had corrosion. Rubber hoses noted, steel threaded hoses recommended. The rubber hoses deteriorate faster than the steel threaded hoses.

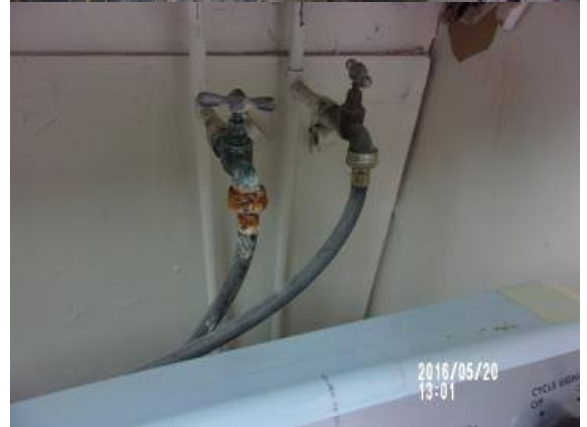
Corrosion noted.

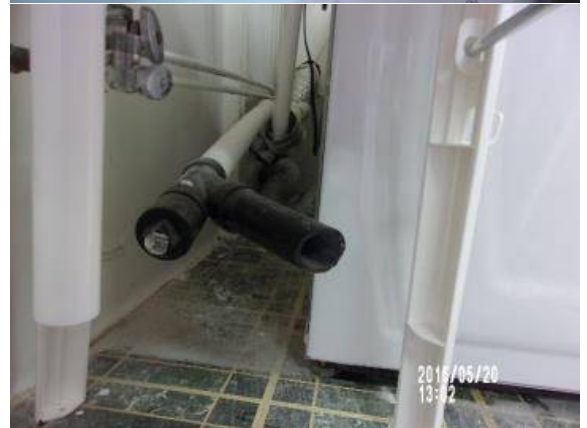
Improper piping/drains noted.

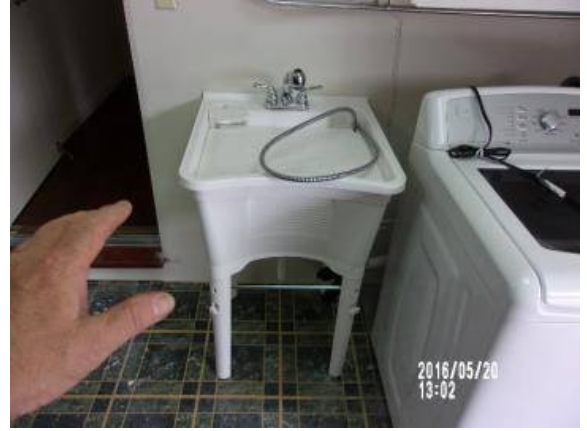
[CR] Laundry sink was disconnected and loose.

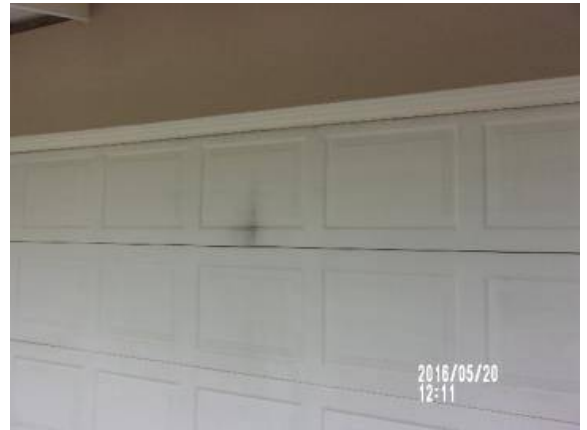
[FE] The garage vehicle door had stains, and made unusual noises when operating, lubrication/adjustment recommended. The weather stripping was missing on the sides and top.

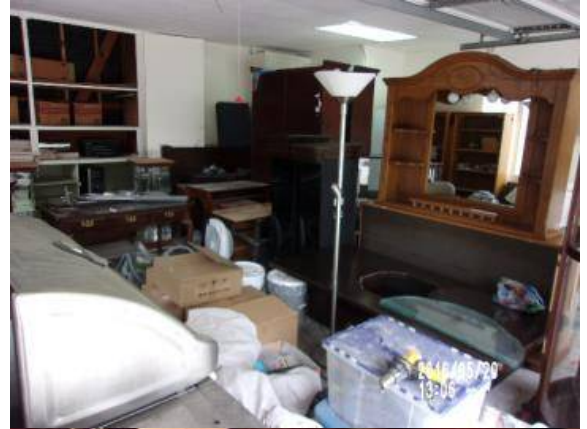
[FE] Personal items in the garage blocked full viewing. The wiring above the ceiling by the opener was improper, over loaded junction box, loose wiring, and junction boxes without covers. Minor light issues noted. Floor tile may contain asbestos.

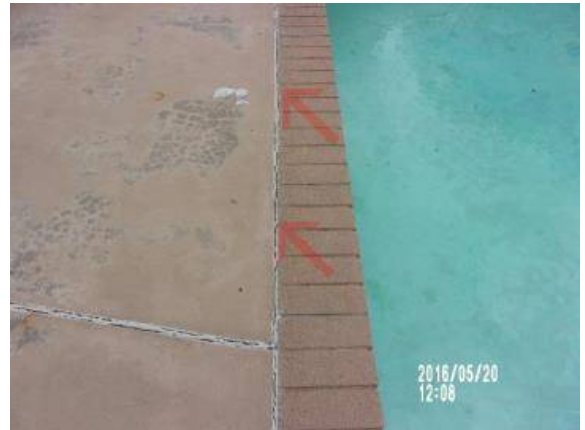
[CR] The caulking between the coping and pool/spa deck surface was cracked/damaged/deteriorated/missing. This condition is conducive to moisture intrusion into concealed spaces.

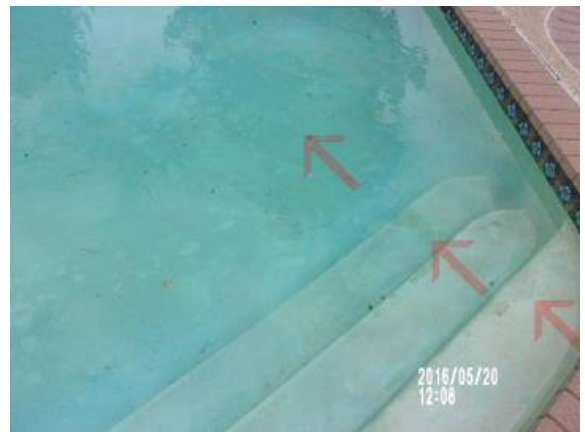
[FE] The pool surface had stains and some deterioration. We recommend a further evaluation by three pool maintenance companies. This can be expensive to repair/resurface. Settling noted by the spa.

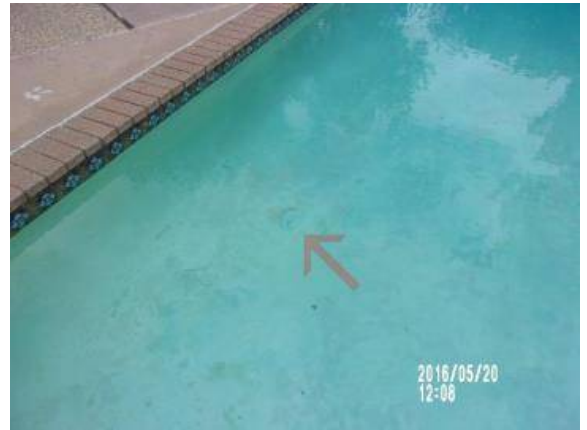
Deterioration.

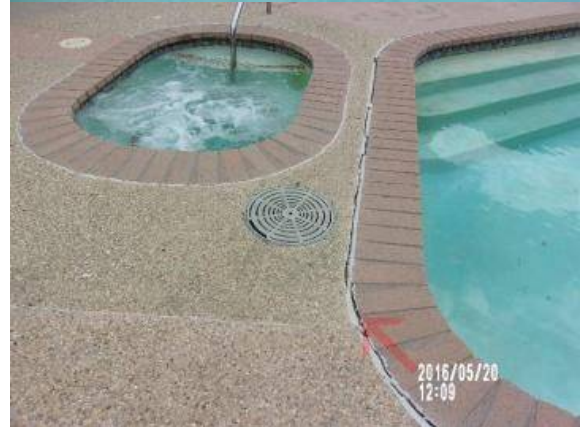
Settling noted.

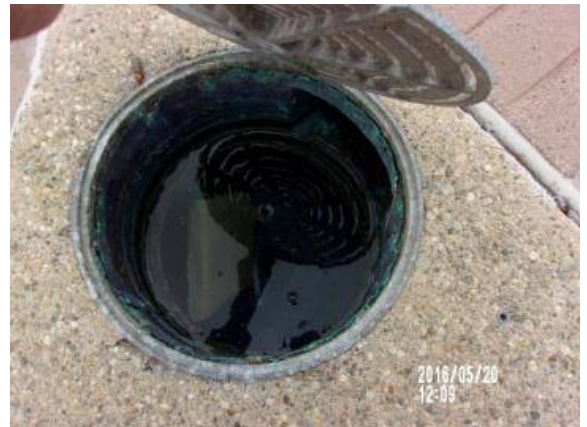
[FE] We recommend inquiring about any leakage conditions past or present. A hose was noted in the pool. Basket was missing.

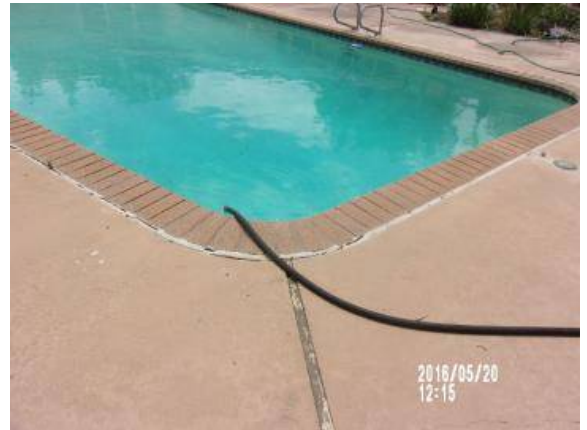
Hose filling pool constantly. Leaks?

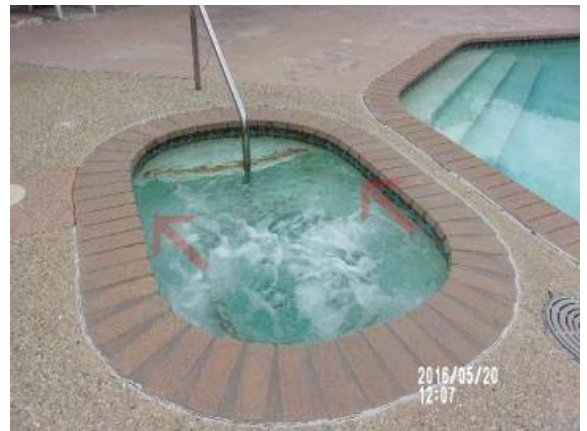
Water flow was noted at the jets. A couple of seats did not have jets.
