Inspection Report Exclusively For: Heesook Park Report Number 3916

RFB PROPERTY INSPECTIONS
 18198 Bryce Ct.
 Fountain Valley, CA 92708
 714-317-3792

FINDINGS

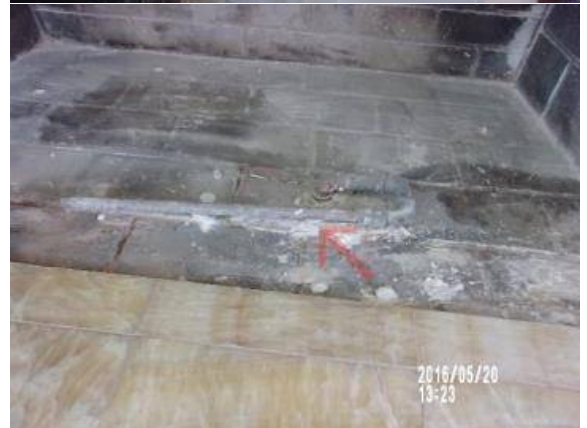
Gas pipe too close to the opening.
