Inspection Report Exclusively For: Heesook Park Report Number 3916

RFB PROPERTY INSPECTIONS
 18198 Bryce Ct.
 Fountain Valley, CA 92708
 714-317-3792

FINDINGS

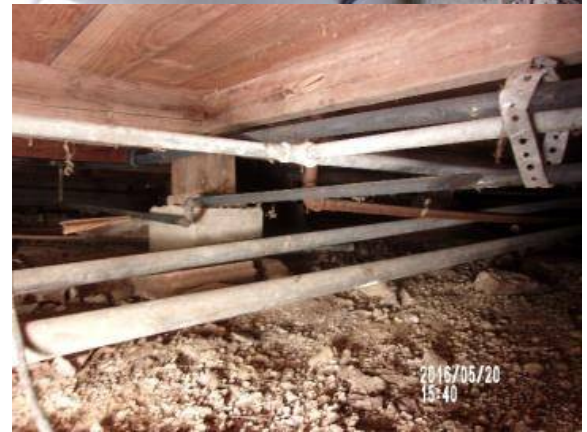
Access difficult with piping that should be removed.

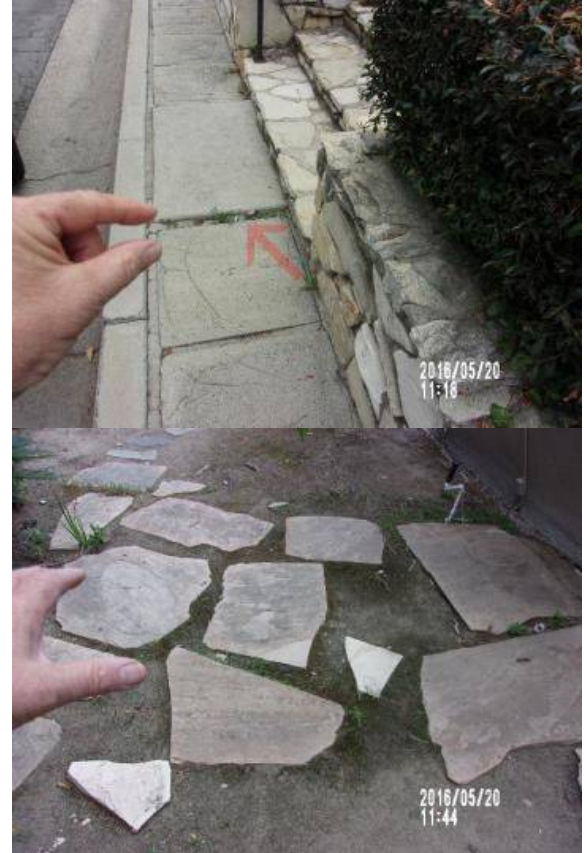
Stepping stones noted.

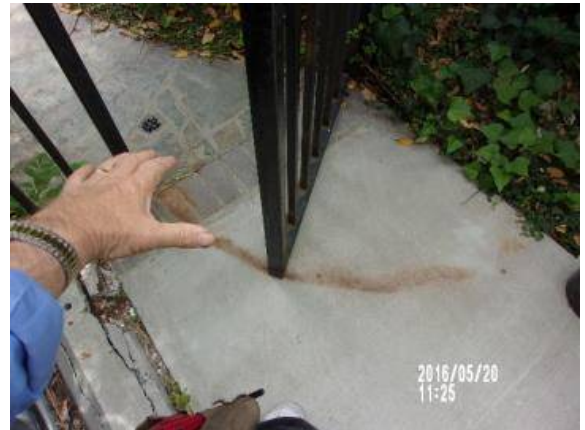
Gate hits the concrete and is not to safety standards .

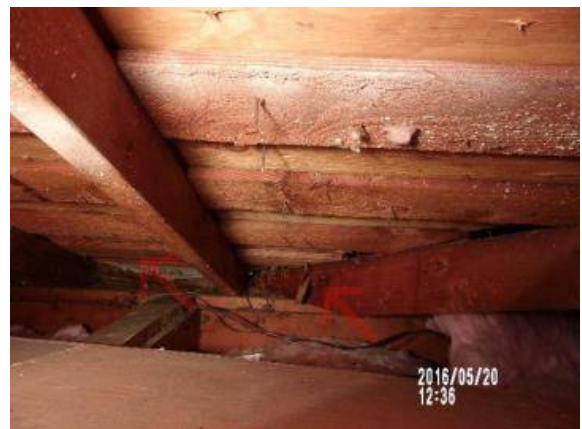
406 ROOF FRAMING

[FE] Moisture stains were noted on the roof framing at various areas. See the termite report for a further evaluation.

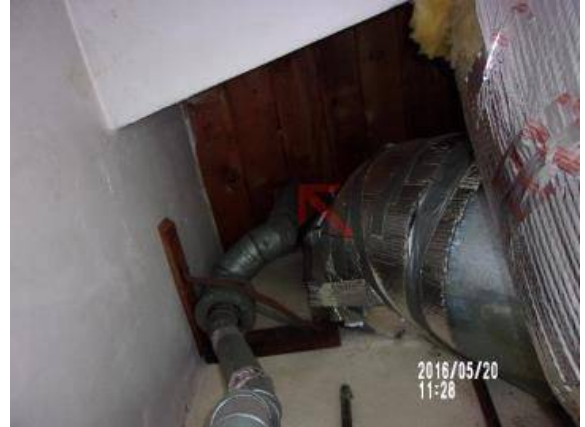
533 VENTING SYSTEM(S)

[SC] The flue vent pipes on all three were not secured at connections as required. Three screws per connection is required. The flue vent piping was close to combustible materials on all three. This condition is a fire hazard. Typically 1 to 6 inches is required for proper clearance.

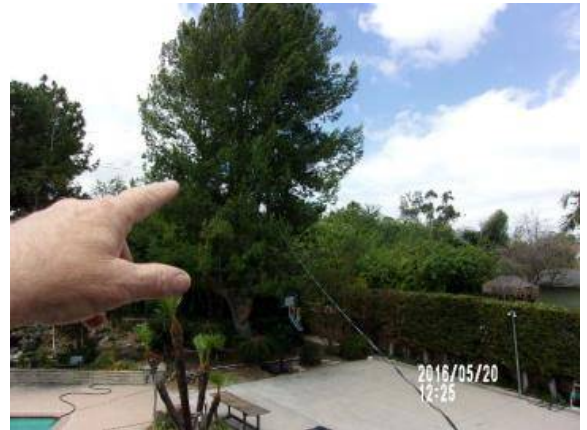
Tree hits the wire.

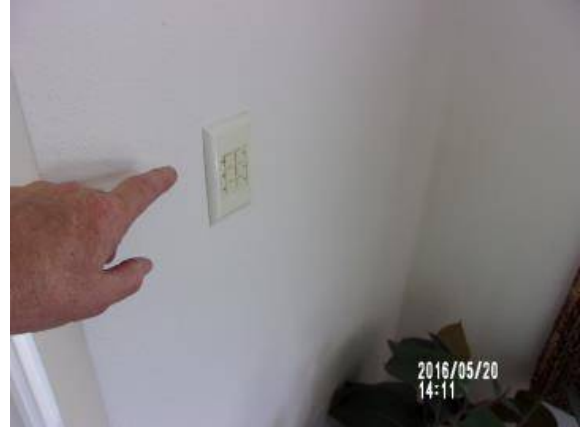
625 SWITCHES

[SC] The light switches in the home were on an older relay system that appeared not to function properly. Have an electrician evaluate the switching system. This may be expensive to repair/replace. Light switch cover damage by the back driveway parking area.

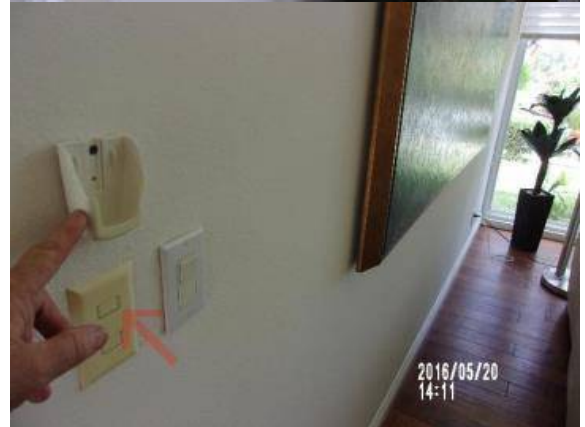
Older switches not functioning properly.

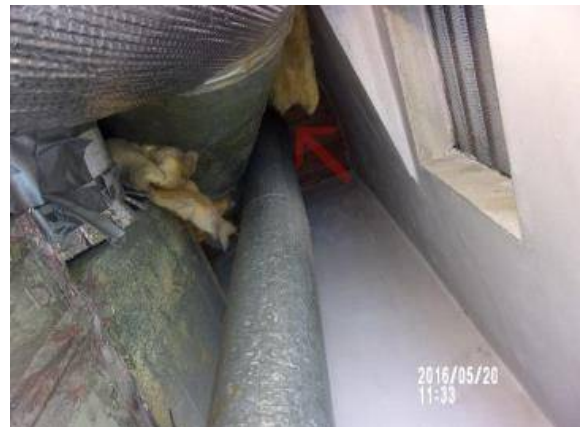
714 VENTING SYSTEM(S)

[SC] The flue vent piping was close to combustible materials and appeared unprofessional. Vent pipe was open on the roof letting rain water through.

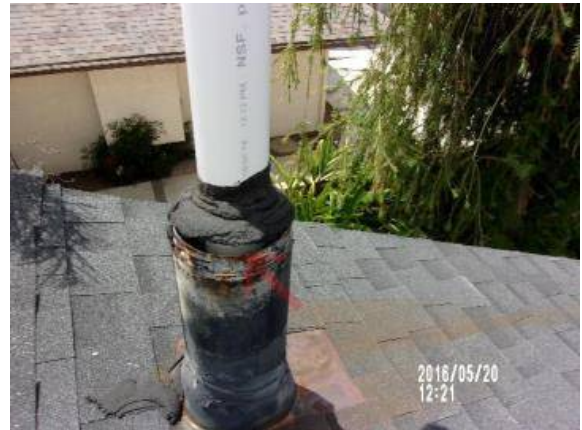
Open at roof, rain water can enter.

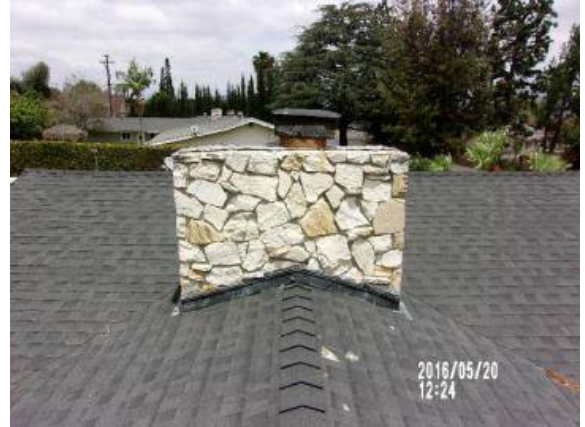
805 CHIMNEY(S)

[FE] The chimney was a little dirty. We recommend a certified chimney sweep clean the chimney. The flashings at the roof were damaged, leaks are possible. The chimney mortar cap was cracked/damaged/deteriorated. These conditions are conducive to moisture intrusion and deterioration. Repairs recommended.

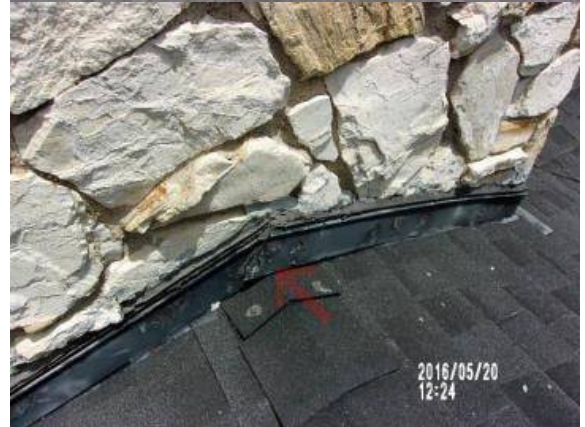
Damage and openings noted.

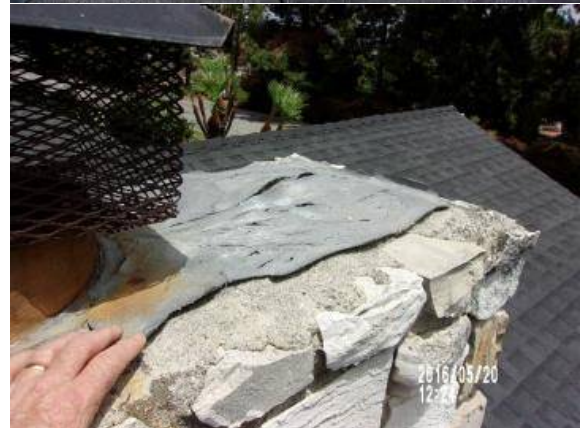
Mortar cap needs repair.

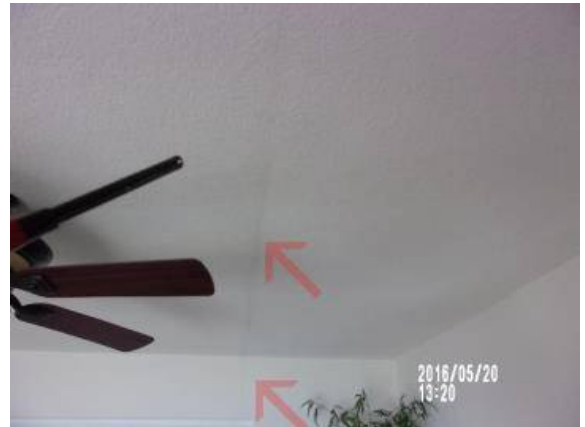
902 WALL(S)/CEILING(S)

[FE] Materials: drywall/plaster, wood. Crack noted in the master on the ceiling and wall. Unprofessional patching of the ceiling noted in the dining area. It appears there is some foundation movement. The rest of the home was newly painted and cracks may have been patched properly and were not visible to see. Ask the seller for all disclosures.

Unprofessional patching.

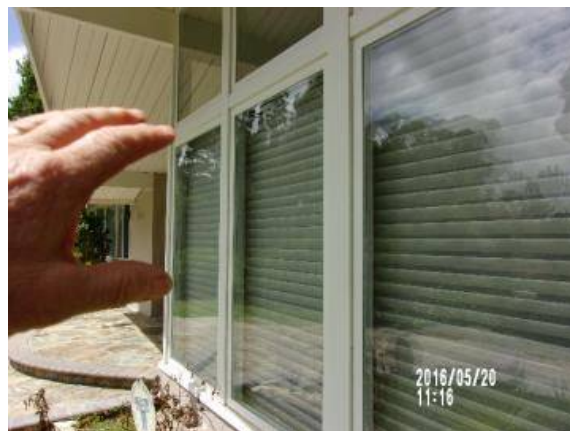
919 WINDOWS

[FE] Newer windows were noted. Permits are recommended to make sure the windows were installed correctly. You should also check if they were installed by a licensed contractor, and if there are any warranties. No moisture stains were noted around or below the windows which would indicate a poor installation. The windows were functional. The kitchen window was difficult to reach and the screen was damaged. The blind handle was damaged in the master bathroom, hall bath and living room facing the side. The blinds did not go all the way down in various areas. Wood shutters need adjustments. Dirty windows noted opposite the front

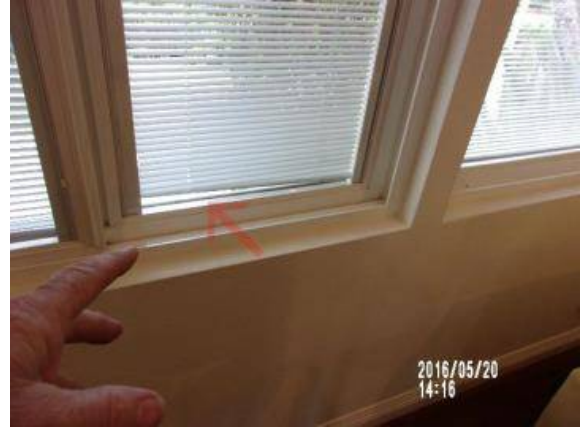
Blinds did not close properly at various windows.

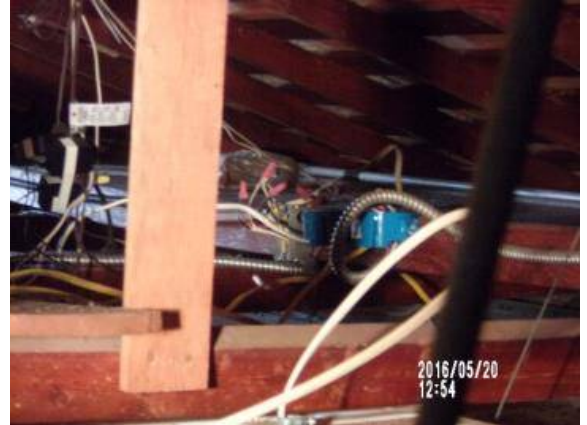
Improper wiring in the garage noted.

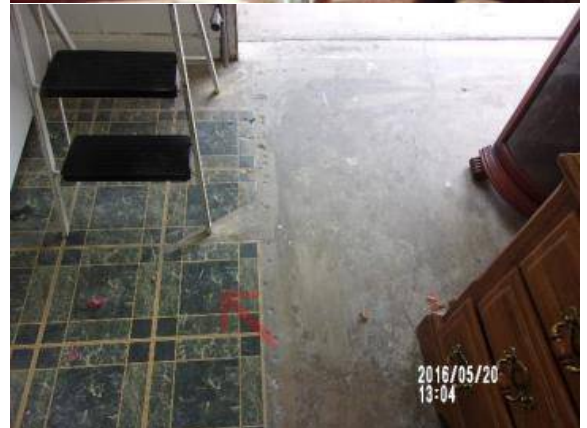
Possible asbestos.

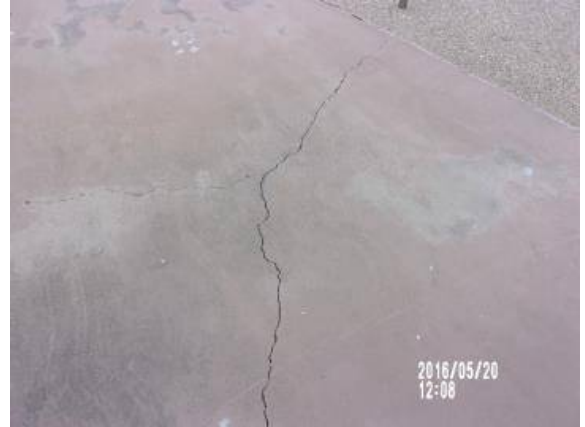
1008 DECKING

[FE] Cracks/seal deterioration noted in the pool/spa decking. This condition is conducive to moisture intrusion and lifting decks.

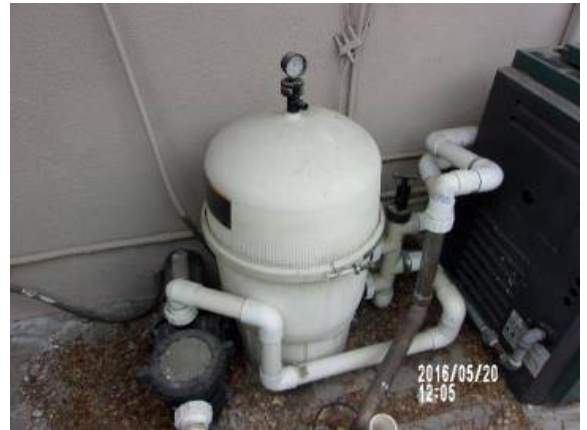
1029 WATER FILTER

The filter was functioning. Ask the age and if there are any warranties. Average life is 15 years.

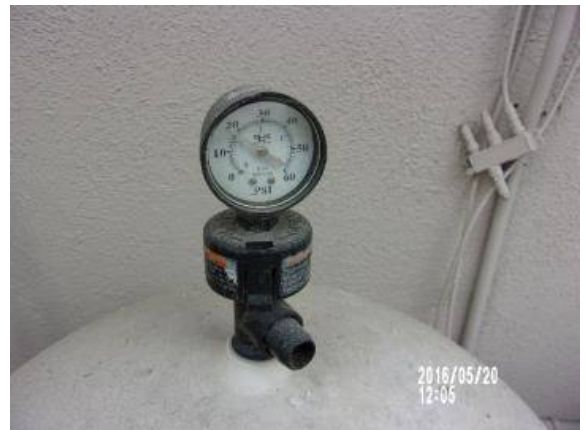
1030 PRESSURE GAUGE

The pressure gauge was functional.

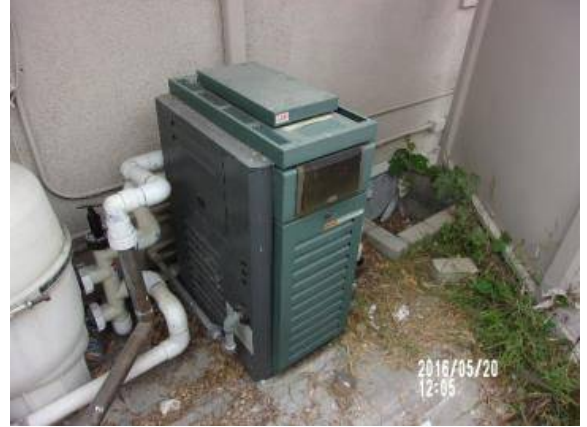
1032 HEATER

[FE] The gas heater did not function. Ask the seller the age and if there are any warranties, average life is 15 years. [RU] These are expensive to run, solar is recommended.
